# Loose Square Drives, Not Lost Corrections: What Five Out-of-Tolerance Torque Transducers Revealed

## SUMMARY

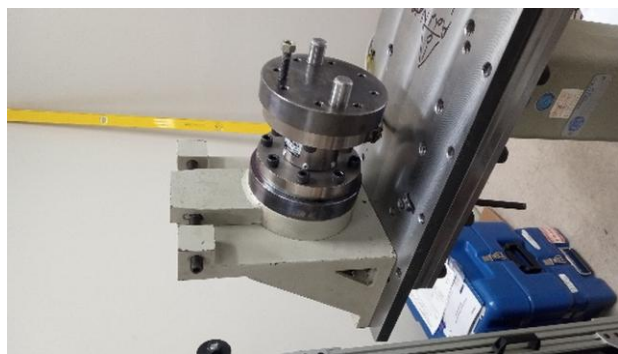
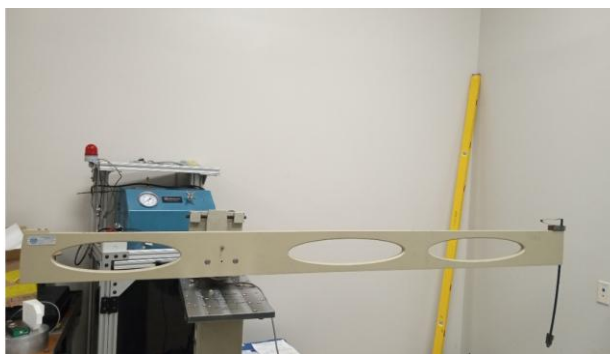
Overhung load is any load on the transducer that is not pure torque about its measurement axis. The most common source is the moment arm itself. A single-ended arm coupled directly to a transducer hangs its own weight on it as a side load, and that side load acts at a distance from the transducer's measurement plane, creating an overturning moment (Figure 3). A 5 ft single-ended arm weighing 35 lbf puts an overturning moment of roughly 87.5 lbf-ft on the transducer before a single calibration weight is added.

*Figure 3. A single-ended unsupported torque arm on a torque cell. The weight of the arm acts at its center of gravity, producing a side load and an overturning moment about the transducer's measurement plane before any calibration weights are applied. From the Morehouse technical paper, Quantifying Overhung Load in Torque Calibration.*

A strain-gage torque transducer is designed so that its bridge responds to shear strain and cancels bending. In practice, the cancellation is never perfect. Small differences in gauge placement, element machining, and bonding leave a residual, so part of any bending load shows up at the indicator as torque. The size of that residual varies from unit to unit and is almost never reported on a certificate. Shaft-style square-drive transducers, like the six in this set, typically have the least bending rejection.
