# Measurement Risk (Measurements gone f\$&4ing wrong!)

2023 ASQ Measurement Quality Division Conference  
“Improving Measurement Confidence and Reducing Risk”  
Sheraton Suites – Cuyahoga Falls, Ohio

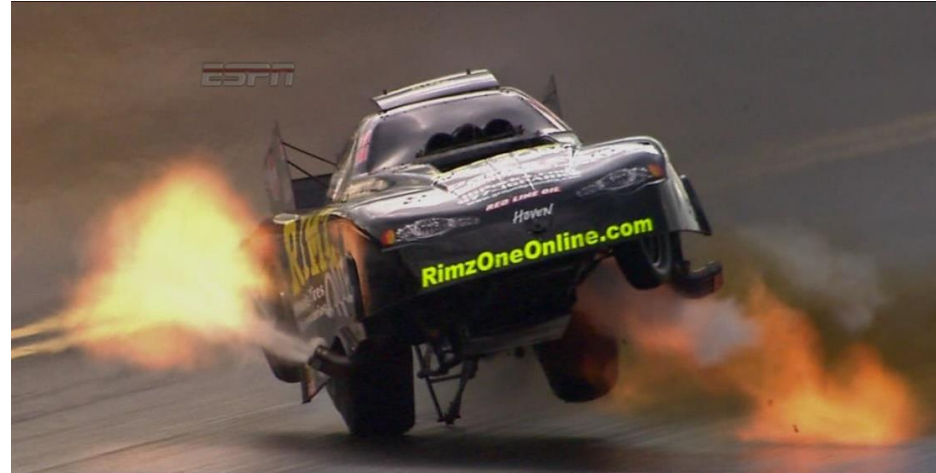
Pictured Right: Metal snap from Jeff Nihel's dragster, apparently the bolts on the left exhaust manifold were over-torqued... bolts then failed, manifold popped off and 4000bhp of exhaust gas launches the car in the air at over 200mph!

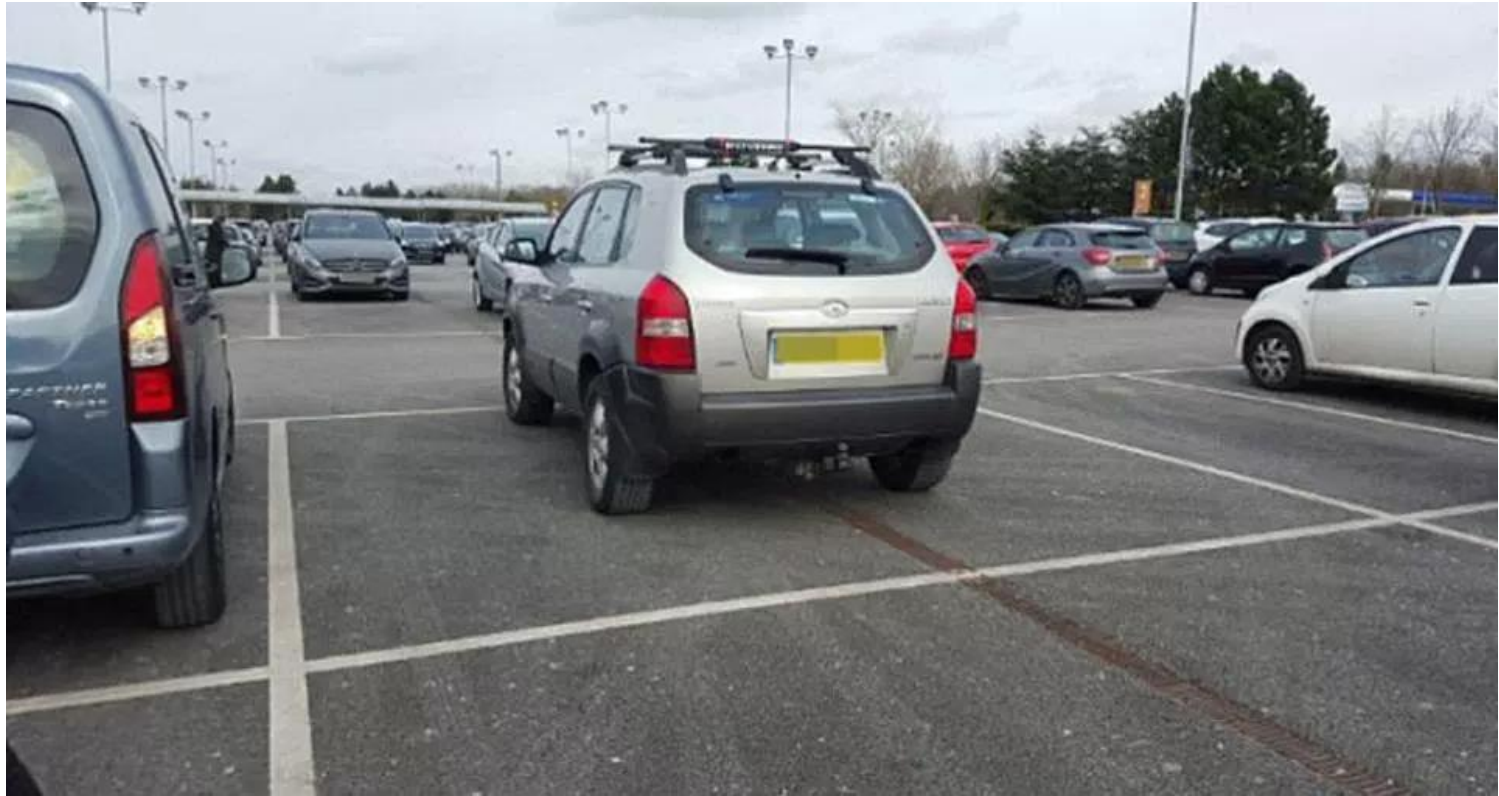
The larger the TUR, the more room you have!

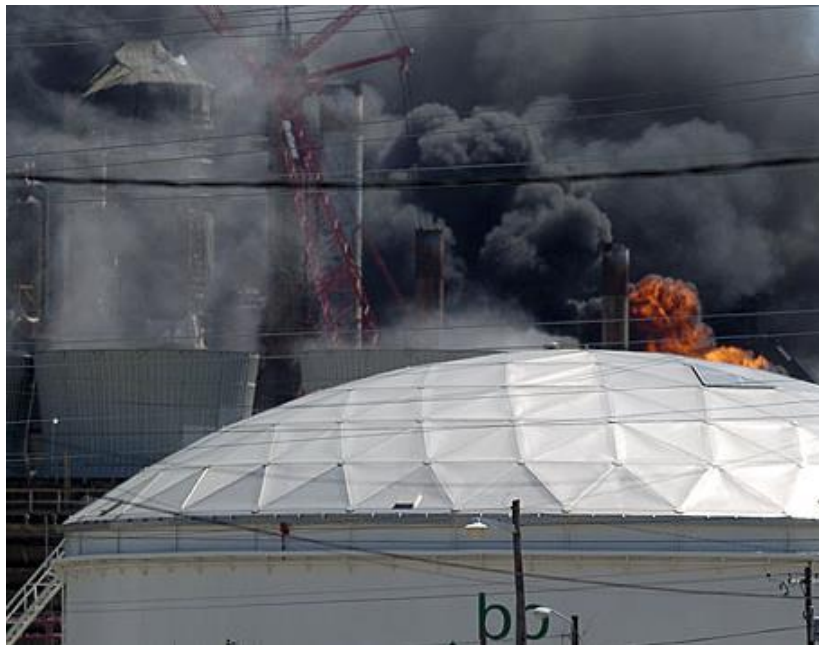
High-level alarm malfunctioned

Level transmitter mis calibrated

- Outdated 1975 data sheet
- Level transmitter indicated liquid level falling
- Level actually rising rapidly

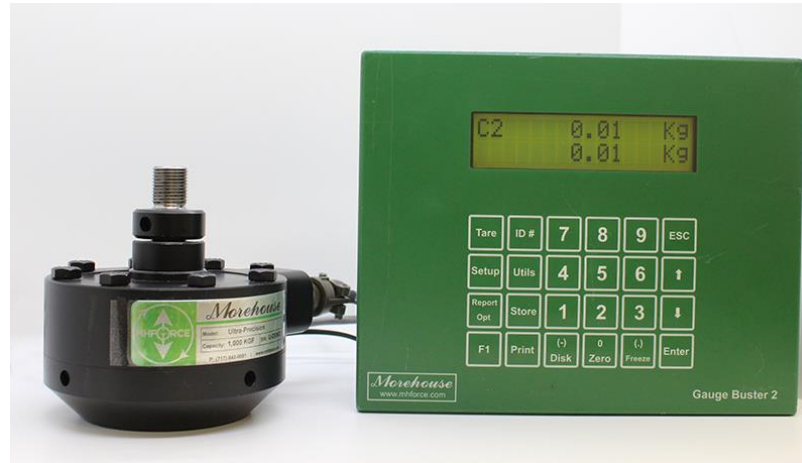
Here we set the resolution to 0.01. What might happen if the resolution were set to 1?

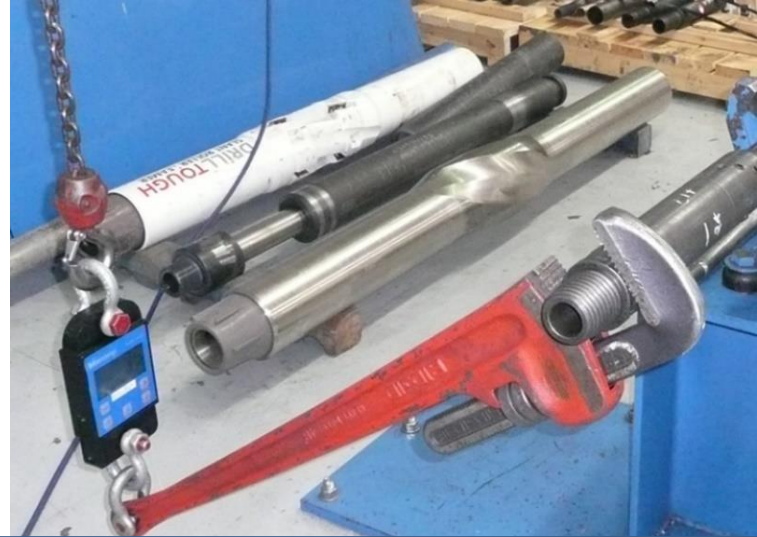
A large, backlit, LCD display and long battery life make the TL8500™ Tension Link a top choice for many different applications and industries.

$\text{Torque} = \text{lift force} \times \sin(t) \times \text{wrench length}$   
 $t = \text{angle}$  and assuming 45 degrees based on visual from picture, sine would be square root of 2 divided by 2 or about 0.71 (This equate to about 29 % error in the torque measurement). If the angle where 90 degrees the sine error goes away.

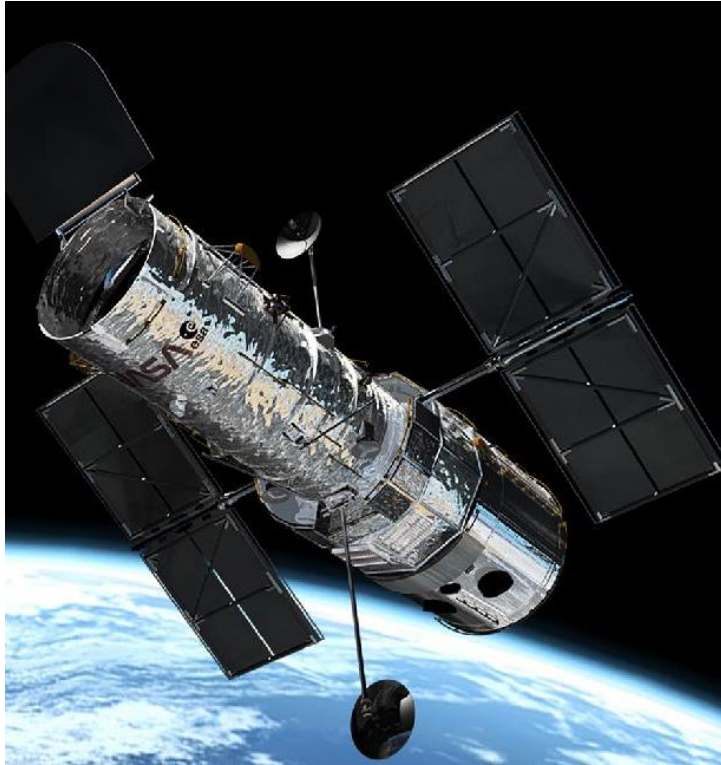
- Hubble Space Telescope (HST) launched April 24, 1990
- On-orbit checkout revealed HST could not be properly focused
- Ensuing investigation indicated the primary mirror was not built to specifications
- A servicing mission to correct the error was flown in December 1993 at a cost of over \$1 billion USD

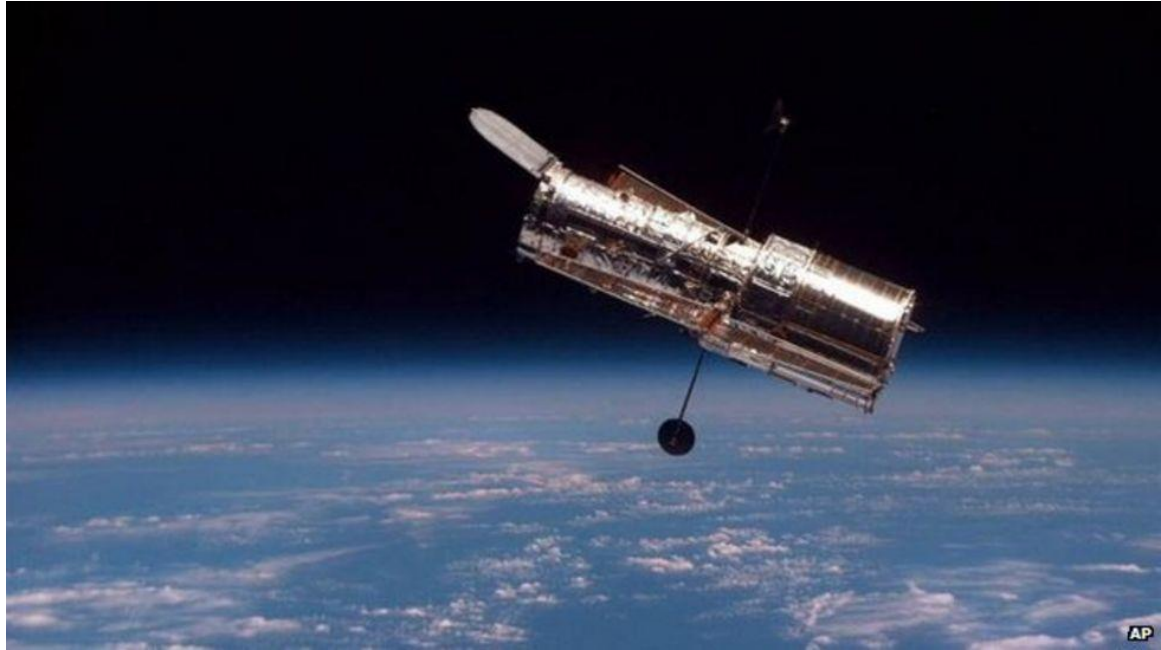
One theory is that a speck of paint on a device used to test the mirror resulted in distorted measurements. Luckily, scientists managed to fix the problem in 1993, using an instrument called the Corrective Optics Space Telescope Axial Replacement (Costar).

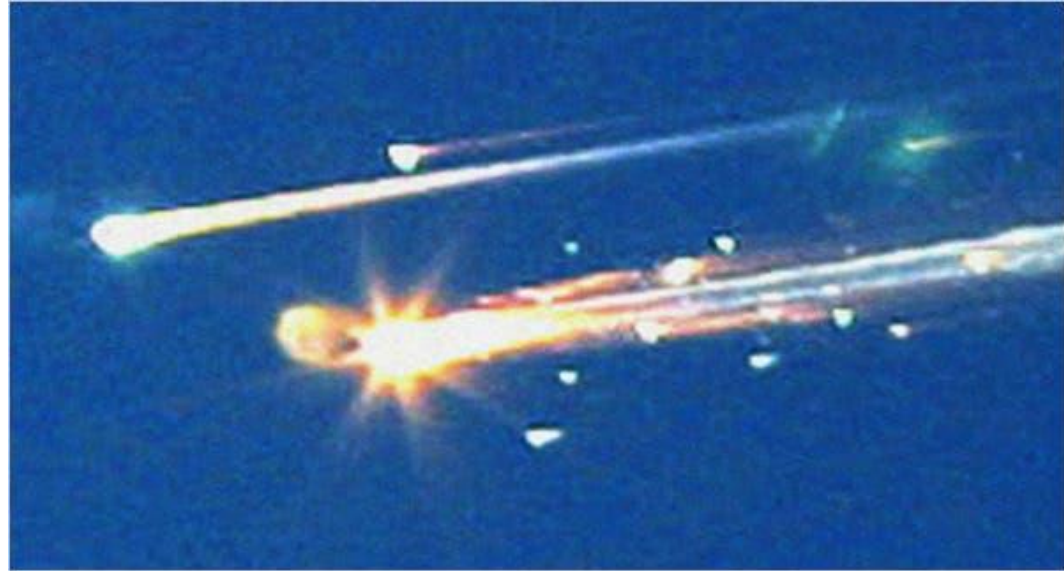
Research showed that despite the years of engineering and planning, the downfall could be attributed to a technical communication failure following the debris damage and prior to reentry. In simple terms, years of engineering work from the smartest minds the world has to offer were undone by a few PowerPoint slides

# Review of Test Data Indicates Conservatism for Tile Penetration

- The existing SOFI on tile test data used to create Crater was reviewed along with STS-87 Southwest Research data
  - Crater overpredicted penetration of tile coating significantly
    - Initial penetration to be described by normal velocity
      - Varies with volume/mass of projectile (e.g. 200ft/sec for 3cu. Ln)
    - Significant energy is required for the softer SOFI particle to penetrate the relatively hard tile coating
      - Test results do show that it is possible at sufficient mass and velocity
    - Conversely, once tile is penetrated SOFI can cause significant damage
      - Minor variations in total energy (above penetration level) can cause significant tile damage
  - Flight condition is significantly outside of test database
    - Volume of ramp is 1920cu in vs 3 cu in for test

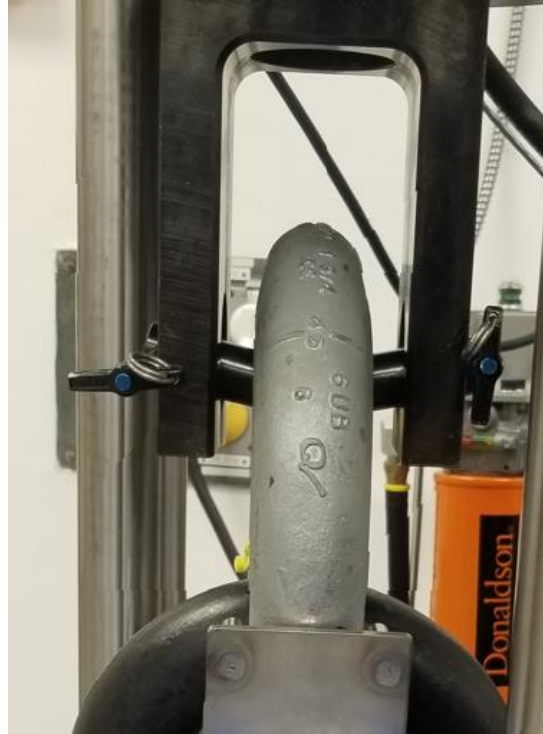
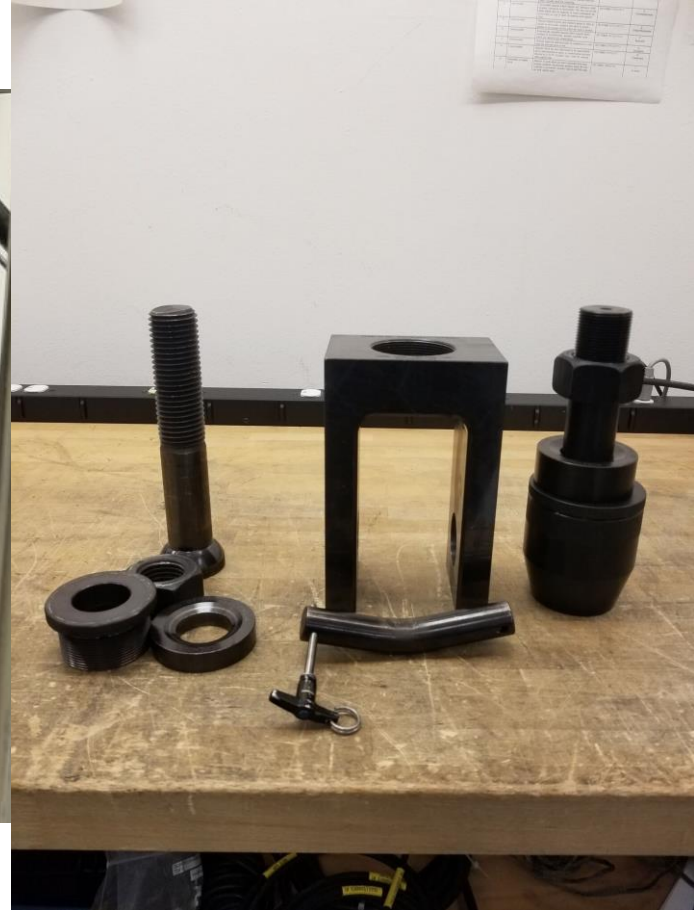
This is what happens when a smaller pin is used for a tension link or crane scale calibration and a driving force behind our Clevis adapters (Patent No. 11,078,052)
